PRELIMINARY INVESTIGATION

Determination of an Area in Need of Redevelopment

BOUROGH OF WOODSTOWN SALEM COUNTY, NEW JERSEY

Supply Industrial District & Vicinity

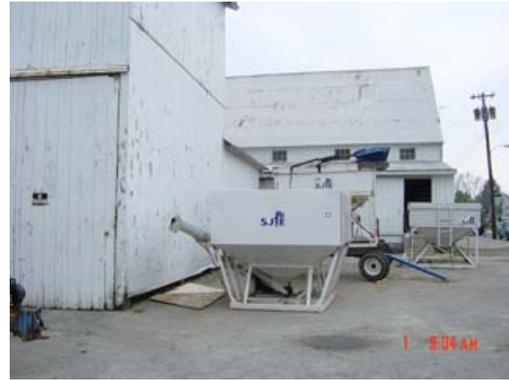
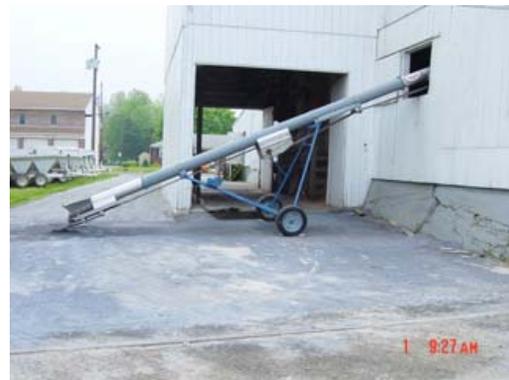
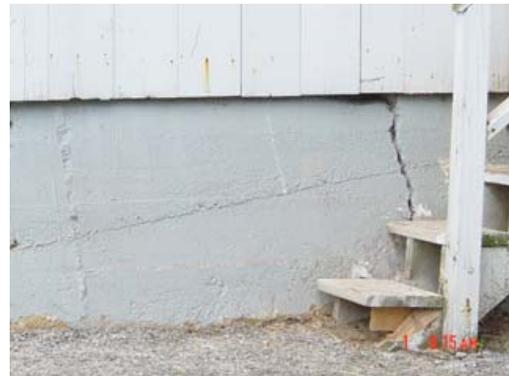
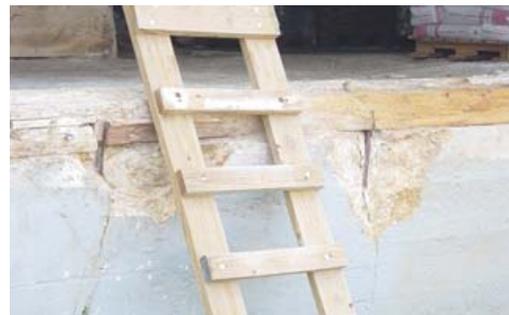
**South Jersey Farmers Exchange –
Block 23, Lot 9**

The South Jersey Farmers Exchange is located within a large building with heavy wood frame construction. The building is almost a century old and exhibits dilapidated pavement and a cracked foundation. Inefficiencies currently exist due to the configuration of the building to suit outmoded operations. Fertilizer mixing is the primary business on the premises and has been for the past few decades. The nature of the business has evolved from a batch blending operation to a “blend to specification” operation whereby fertilizers are mixed, delivered and applied on the same day.

The building also has antiquated mixing equipment that is no longer appropriate for the current business operation and the rail side is obsolete given that the operation requires heavier cars for delivery. Overall, the building exhibits dilapidation and is obsolete given the nature of the current operation.

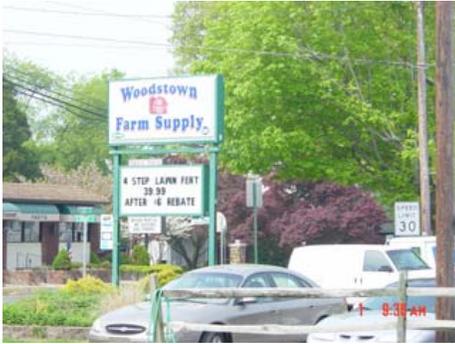
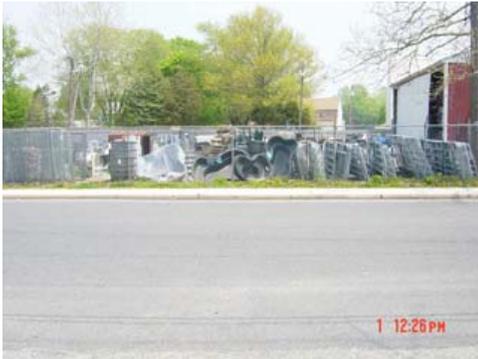
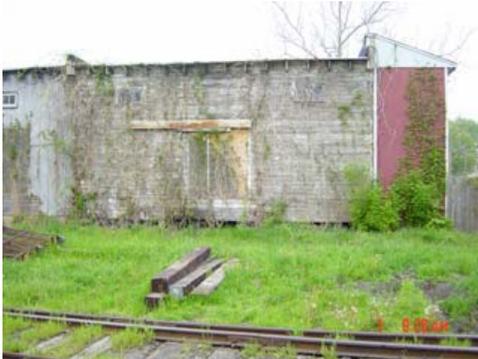
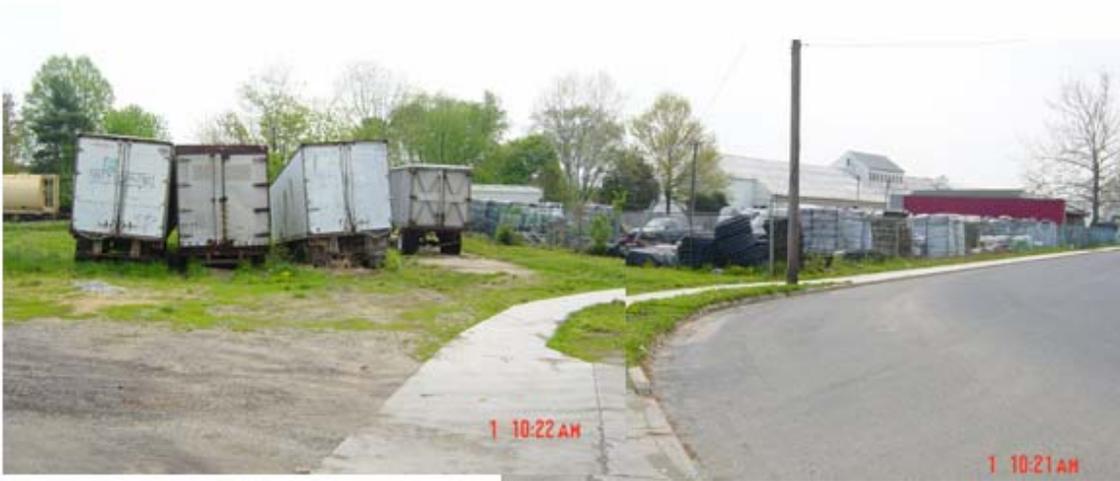
**Woodstown Farm Supply –
Block 18, Lot 31**

The Woodstown Farm Supply utilizes a wooden frame building for retail and storage. The building exhibits dilapidation at both the rear portions of the site and in the foundation of the storage area. In addition, a significant outdoor storage of supplies and equipment is present without adequate buffering.

Adjacent to the market’s storage/distribution area is a parcel on which tractor trailers are located (see photo below). These are strewn about the property and exhibit neglect and deteriorated conditions, Fencing has not been provided or adequate security lighting, contributing to hazardous conditions. The site has the potential of becoming an attractive nuisance, especially considering the close proximity of the site to residential uses.

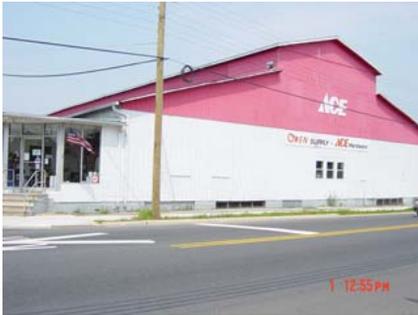
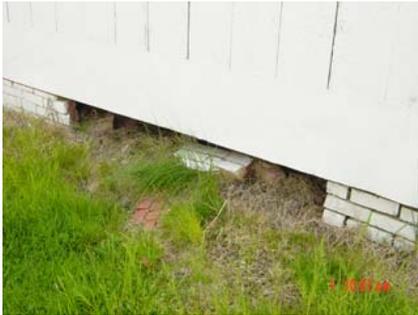
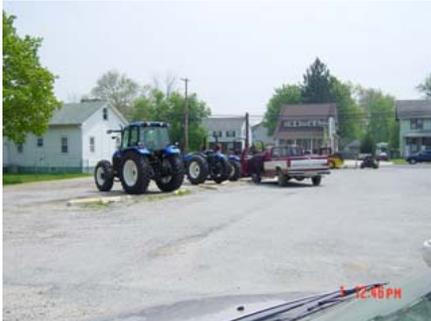
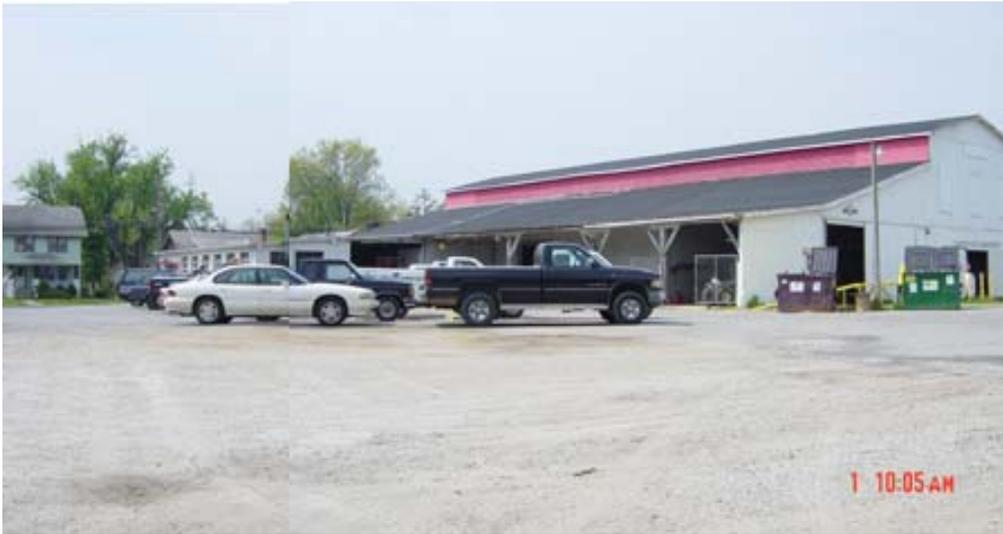
**Owen Supply Property –
Block 24, Lots 2, 19, 20**

Ace Hardware and New Holland Sales share the same wooden frame building, which exhibits depilation as evidenced by a cracked foundation is cracked and significant pavement deterioration. It appears that there is excessive building coverage that exceeds the requirements of the present retail use.

Faulty arrangement of buildings and parking areas is also evident on the site. Tractors for sale are currently located within the parking area with no clear delineation between tractor inventory and patron parking.

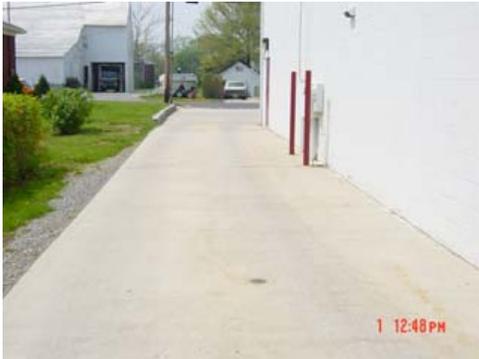
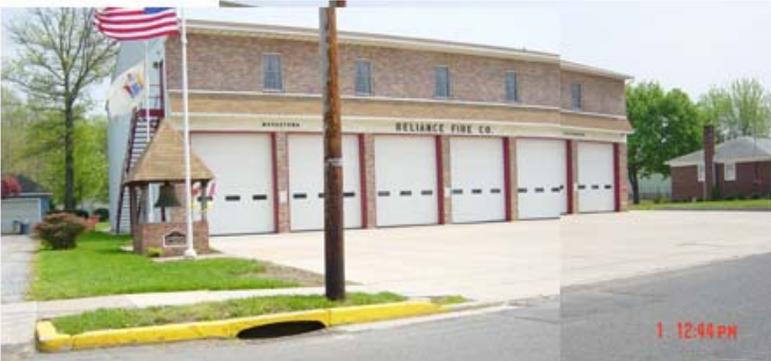
Fire House – Block 24, Lots 21

The fire house is a relatively new building in comparison to other structures within the study area. However, personnel responding to an emergency currently access the site via Route 40 from the rear of the site given the narrowness of the existing pavement adjacent to the southerly elevation of the fire hall. This requires vehicles to use the drive aisles and parking lots of adjoining properties, creating the potential for hazardous conditions.

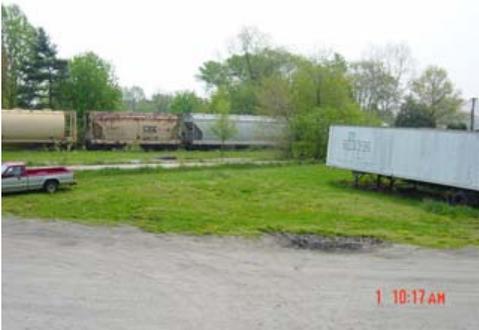
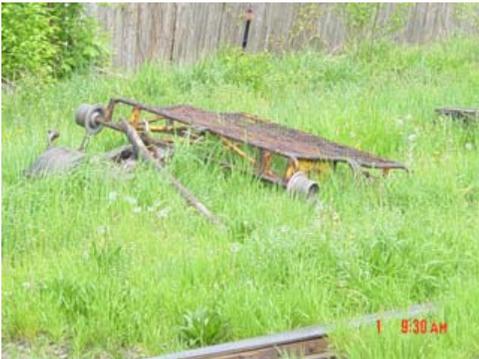
**Railroad Parcels –
Block 500, Lots 2 and 3**

Two (2) parcels within the study area are railroad parcels. Although the railroad is currently in operation, the railroad tracks and ties are in need of repair and maintenance. Ties adjacent to the Farmer’s Exchange are of insufficient gauge to accommodate the weight of the rail cars required to service current operation of the business.

There is also trash and rusty machinery strewn around the railroad tracks. Although the trains travel at a relatively low rate of speed, there is a lack of fencing or signage preventing the public from accessing the site, creating a potentially hazardous condition.

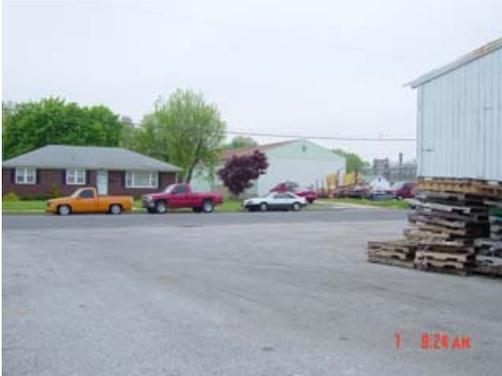
Photo 1

A single family residential use is located in the R5 district between Owen Supply and the fire house (see photo 1). An additional single family residential use is located in the R3 district adjacent to TJ’s Lawn and Landscape located in the Commercial district (see photo 2).

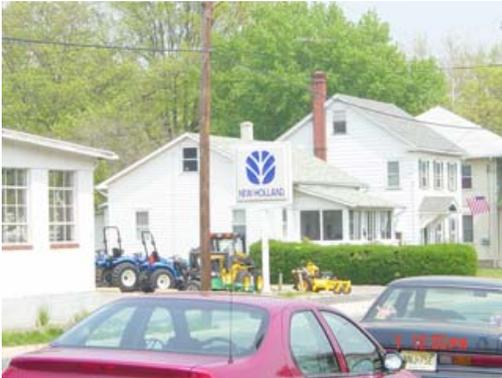
Photo 3

In addition, appropriate buffering has not been provided to buffer the residential uses from the commercial and industrial uses within the study area (see photo 3).

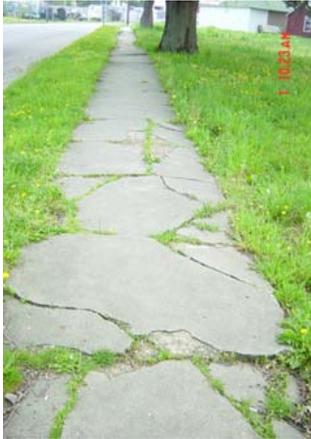
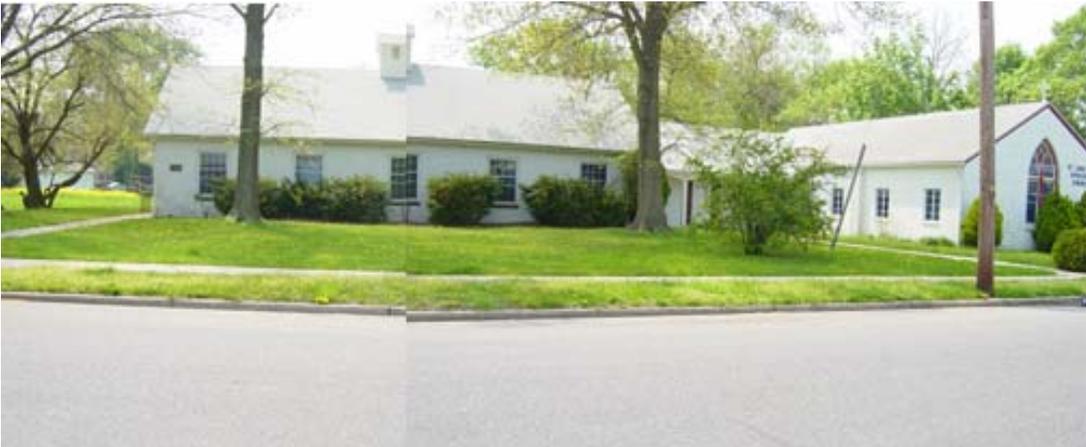
**Saint Lukes Church –
Block 20, Lot 15**

The church is located on the edge of the study area in the R5 zone and is a permitted conditional use within the R5 zone. The off-street parking is limited to a paved pad that does not have stalls delineated and is currently insufficient to accommodate the needs of a congregation. The sidewalk is also in poor condition.

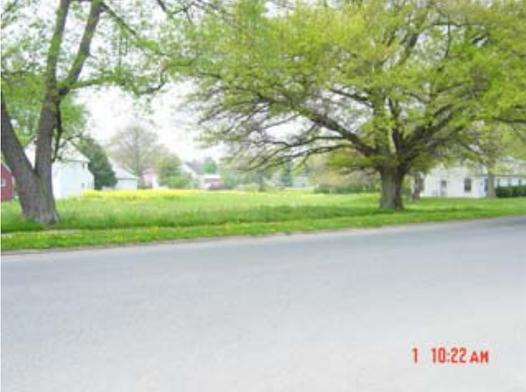
Photo 1

There are three parcels within the study area that are unimproved vacant land. Adjacent to Saint Lukes Church is an expanse of unimproved vacant land on which a residence was once located (see photo 1). Unimproved land is also located on the church property with frontage on Grant Street (see photo 2). The unimproved land extends behind existing housing to Bowen Avenue. Additional vacant land is located on the property of Woodstown Ice & Coal adjacent to the railroad at the corner of Broad and Elm Streets (see photo 3).

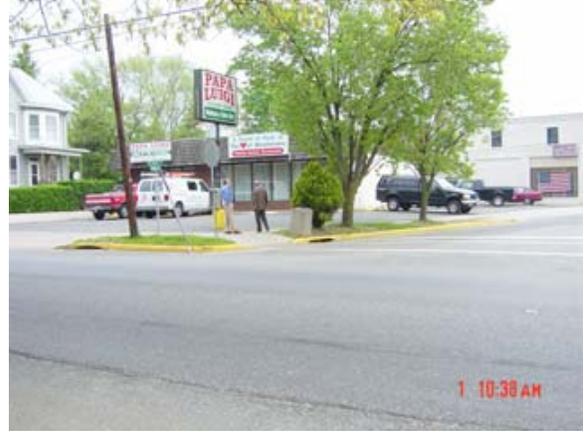
Luigi's Restaurant – Block 20, Lot 37

The site in question currently houses two retail establishments. The physical design of site exhibits faulty arrangement in both the situation of the building and the parking arrangement. Parking is currently located in the front of the building along Route 45 for Luigi's Italian restaurant, requiring that vehicles back out into on-coming traffic and across the sidewalk, endangering pedestrians. The design is out of character with the retail establishments along the same street frontage towards Route 45, which have zero setbacks.

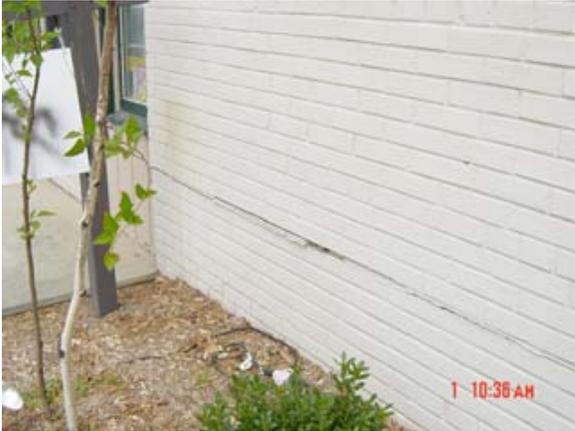
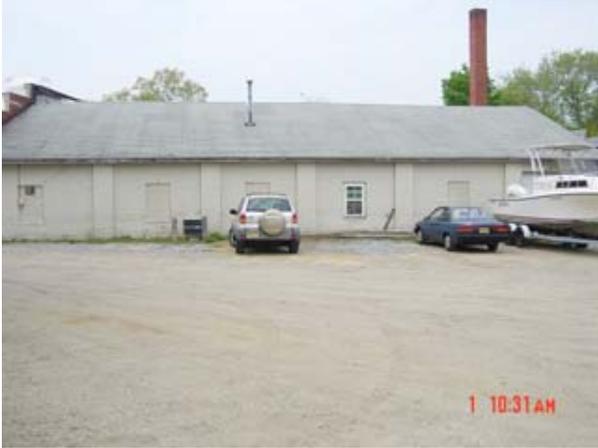
**TJ’s Lawn and Landscapes – Block 20,
Lot 28**

The building containing TJ’s Lawn and Landscapes, which abuts the retail establishments on Route 45, exhibits cracked walls. Many of the windows have been boarded for warehousing purposes, preventing light and ventilation within the structure.

The site also has a significant expanse of unimproved on-site parking, which appears to be in excess to accommodate the typical demand of the present use of the building, suggesting that there exists an underutilization of land which would otherwise be beneficial to economic well being of the community.

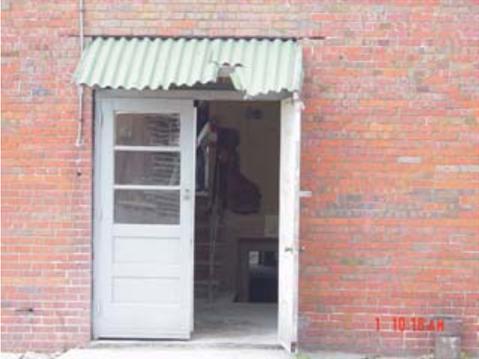
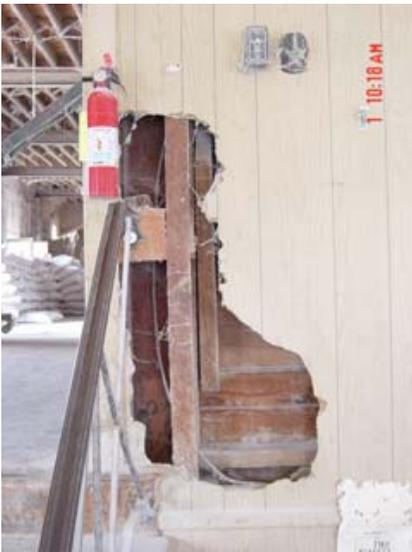
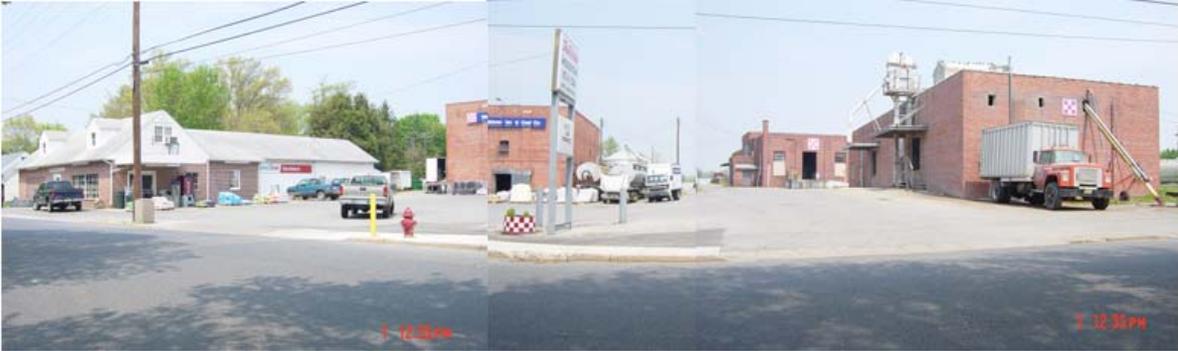
**Woodstown Ice & Coal –
Block 18, Lots 29, 34; Block 23, Lot 1**

Woodstown Ice & Coal is comprised of three brick buildings that exhibit outward signs of deterioration and a small retail establishment that is located on a separate parcel. The site can be accessed from both Grant Street and Elm Street due to an access drive traversing the length of the parcel. Circulation on the site is ill-defined, and subsequently hazardous due to the mix of large trucks, private vehicles and pedestrians. The land is largely underutilized.

Currently, the manufacturing aspect of the business is limited to one building. The additional two buildings are used for storage. The rear of the site is largely vacant and contains tanks. The site is also unfenced, contributing to potentially hazardous conditions.
